Management of an Infection Cluster in ICU

A Journey with *Serratia marcescens*

The *Serratia marcescens* infection cluster in ICU

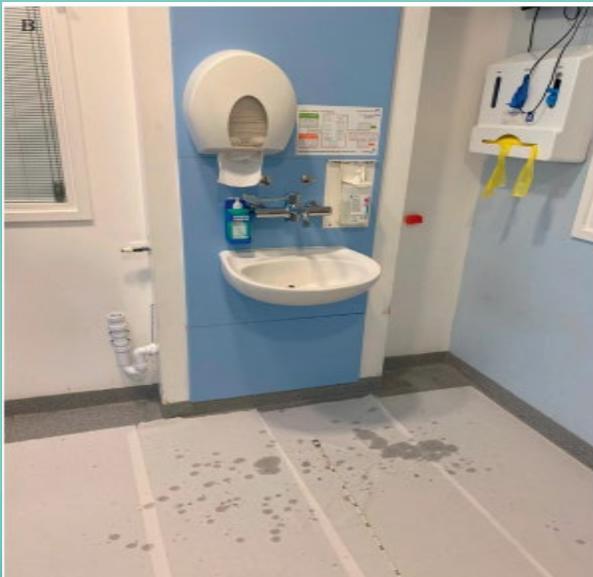
The sink splash zone. © 2023 The Healthcare Infection Society.

- Are to have curved sides, to minimise splashing; - do not include integrated plugs
- Alignment of the waterspout should ensure the water flow does not run directly into the drain aperture, thus avoiding aerosol splashback to the hands and face of the user. The waterspout will be positioned to ensure the water flow hits at the front of the basin, sink or trough.
